INSTRUCTIONS FOR FORD SPORT UTILITY CASTER/CAMBER TOOL

2002 and newer Ford Explorer

2002 and newer Mercury Mountaineer

Ford Explorer Tool inst. sheet
95-193-0901

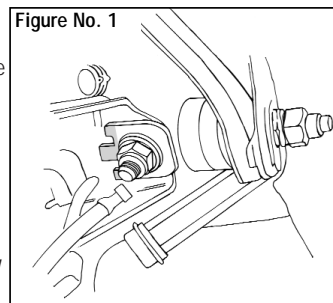
Beginning with the 2002 model year Ford Explorer and Mercury Mountaineer front upper control arms are locked within the frame bracket by four factory installed fixed plates (2 per side) See **Figure No. 1**.

The plates must be removed and replaced with washers to allow for adjustment of the control arm within the frame slot (contact your alignment products supplier).

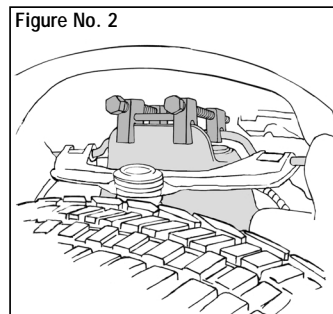
1. Perform pre- alignment check for worn or damaged parts. Check Tire pressure and adjust as needed.
2. Install alignment equipment and take initial readings to determine amount of change needed.
3. Raise vehicle in a safe manner **Note: Vehicle must be supported under the lower control arms with appropriate safety devices.**
4. Remove tire & wheel assembly.
5. Remove both "square" factory fixed plates (on each shaft assembly-2 per side).
6. Install new washers and loosely install locking nuts but do not tighten at this time.
7. Install tire and wheel assembly recompensate alignment equipment.
8. Install alignment tool having front blocks attach to coil spring tower and back adjusting blocks attached to control arm shaft assembly See **Figure No. 2**.

NOTE: For positive camber adjustment rotate adjustment bolts equally; counter clockwise. For negative camber adjustment rotate adjustment bolts equally; clockwise.

9. Rotate adjusting bolts as needed to achieve caster/camber per vehicle specifications.
10. With alignment tool holding control arm in place; tighten upper arm shaft assembly nuts to factory specifications.
11. Proceed with the rest of the alignment; set toe and road test vehicle.

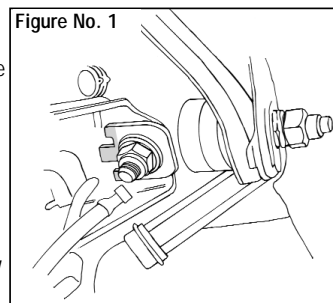
Beginning with the 2002 model year Ford Explorer and Mercury Mountaineer front upper control arms are locked within the frame bracket by four factory installed fixed plates (2 per side) See **Figure No. 1**.

The plates must be removed and replaced with washers to allow for adjustment of the control arm within the frame slot (contact your alignment products supplier).

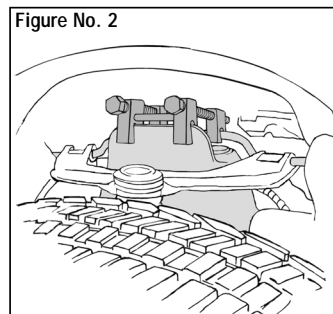
1. Perform pre- alignment check for worn or damaged parts. Check Tire pressure and adjust as needed.
2. Install alignment equipment and take initial readings to determine amount of change needed.
3. Raise vehicle in a safe manner **Note: Vehicle must be supported under the lower control arms with appropriate safety devices.**
4. Remove tire & wheel assembly.
5. Remove both "square" factory fixed plates (on each shaft assembly-2 per side).
6. Install new washers and loosely install locking nuts but do not tighten at this time.
7. Install tire and wheel assembly recompensate alignment equipment.
8. Install alignment tool having front blocks attach to coil spring tower and back adjusting blocks attached to control arm shaft assembly See **Figure No. 2**.

NOTE: For positive camber adjustment rotate adjustment bolts equally; counter clockwise. For negative camber adjustment rotate adjustment bolts equally; clockwise.

9. Rotate adjusting bolts as needed to achieve caster/camber per vehicle specifications.
10. With alignment tool holding control arm in place; tighten upper arm shaft assembly nuts to factory specifications.
11. Proceed with the rest of the alignment; set toe and road test vehicle.
